**Flood Control Project Maintenance
Levee Inspections**

Maintenance Issue Types Only, Levee Inspection Report By Mile - Spring 2019

Reclamation District No. 0341 Sherman Island

Waterway	Bank	Unit Miles	Inspection Start/End	Inspector
Unit No. 01 Threemile Slough	Right	3.36	03/28/2019 03/28/2019	David Julian

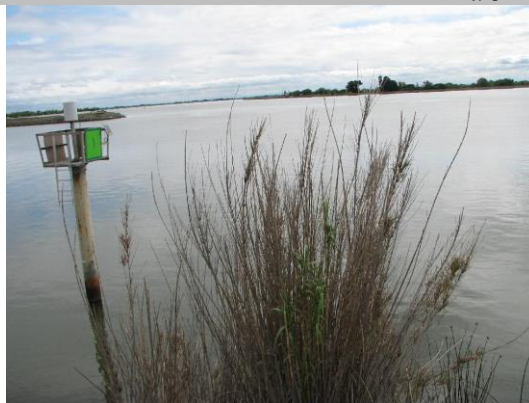
Photo 1 of 3 : UCIP_SP_2019_52252_37640.jpg

Comment Code					
Inspector Comment					
FS_ID:52252 DS_ID:24215 EP_NO: N/A Repair Type: Non-Urgent Crossing Status: Found UCIP Comments: 05/05/2009 Dense vegetation limits the inspector's visibility to identify signs of pipe failure (leaks) along the slopes. Recommend removing vegetation along pipe alignment to conduct proper inspection of structure and appurtenances. (DWR UCIP - O. Magana) FIELD_STRUCT_DESC: 30-inch steel drainage pipe through the levee 11.1 feet below the crown. Corrugated metal cutoff wall around pipe at the center of the levee. Siphon breaker is located on both waterside (WS) and landside (LS). Pump is located on the LS approximately 300 feet from LS toe. Pipe is exposed on both levee slopes. Rock revetment present along WS slope. Marine Station number 1 located on WS with an attached small solar panel on top. [Additional Reference(s): DWR Levee Log, 1992. USACE Sacramento O&M Manual Unit No. 101, February 1962, (HLM 0.0). LMA encroachment station (STA) reference based on Map of Evacuation Route, Reclamation District 341 Sherman Island by Wagner Bonsignore Consulting Civil Engineers, A Corporation dated July 2012, STA 175+00]. FS Date: 5/5/2009

Marine station posts in river identified as Station 1 near crossing.

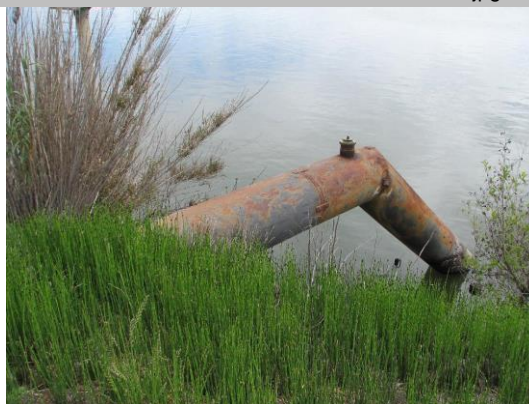
Photo 2 of 3 : UCIP_SP_2019_52252_37644.jpg

View of pipe and siphon breaker located on WS--dense vegetation on slope.

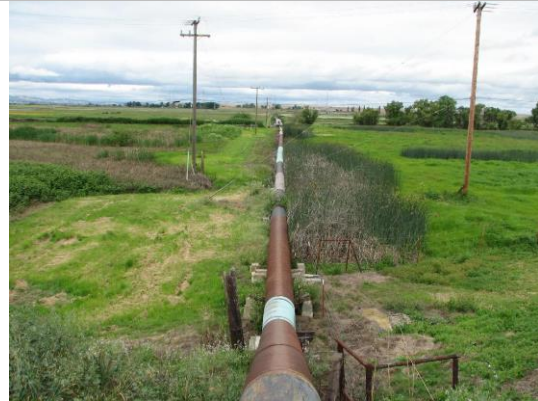
Photo 3 of 3 : UCIP_SP_2019_52252_37642.jpg

Comment Code					
Inspector Comment					
FS_ID:52252 DS_ID:24215 EP_NO: N/A Repair Type: Non-Urgent Crossing Status: Found UCIP Comments: 05/05/2009 Dense vegetation limits the inspector's visibility to identify signs of pipe failure (leaks) along the slopes. Recommend removing vegetation along pipe alignment to conduct proper inspection of structure and appurtenances. (DWR UCIP - O. Magana) FIELD_STRUCT_DESC: 30-inch steel drainage pipe through the levee 11.1 feet below the crown. Corrugated metal cutoff wall around pipe at the center of the levee. Siphon breaker is located on both waterside (WS) and landside (LS). Pump is located on the LS approximately 300 feet from LS toe. Pipe is exposed on both levee slopes. Rock revetment present along WS slope. Marine Station number 1 located on WS with an attached small solar panel on top. [Additional Reference(s): DWR Levee Log, 1992. USACE Sacramento O&M Manual Unit No. 101, February 1962, (HLM 0.0). LMA encroachment station (STA) reference based on Map of Evacuation Route, Reclamation District 341 Sherman Island by Wagner Bonsignore Consulting Civil Engineers, A Corporation dated July 2012, STA 175+00]. FS Date: 5/5/2009

Overview of LS slope above ground once it exits levee. Pump is located approximately 300 feet from levee toe.

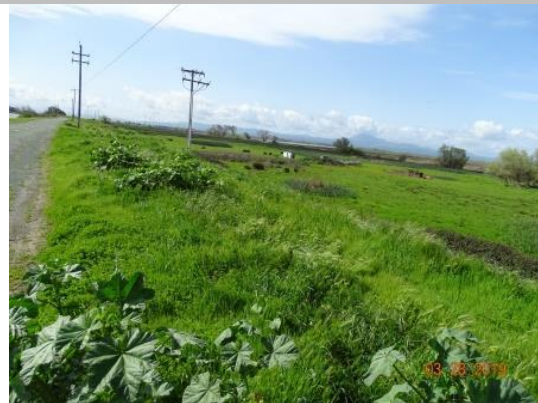
Photo 1 of 1 : SP_2019_RD0341_167_29_20190329_00053.jpg

LM Start	0.00	Rating **	U	Issue No.	29
LM End	0.75	Issue Type +	Ma	Location *	LS
Category	Earthen Levee			GPS Latitude/Longitude	
				Start	End
Item	Vegetation			38.085573 °	38.096376 °
				-121.686495 °	-121.686952 °
DWR ID	DWR_RD0341_01_s_2019_29				
Comment Code					
V1 : Control annual grass and weeds on the levee slopes and easements.					
Inspector Comment					
Maintain annual vegetation on the landside slope

View looking downstream at annual vegetation on the landside slope (Spring 2019).

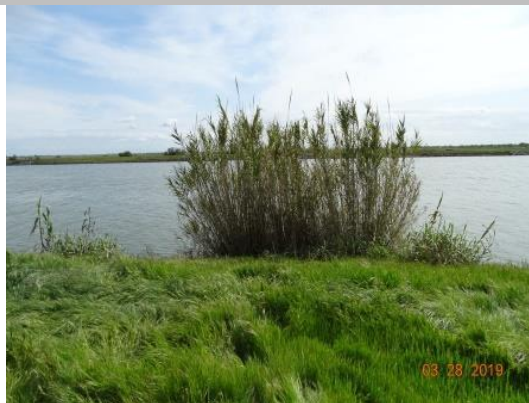
Photo 1 of 1 : SP_2019_RD0341_167_32_20190329_00055.jpg

LM Start	0.74	Rating **	M	Issue No.	32
LM End	0.74	Issue Type +	Ma	Location *	WS
Category	Earthen Levee			GPS Latitude/Longitude	
				Start	End
Item	Vegetation			38.096136 °	38.096136 °
				-121.686953 °	-121.686953 °
DWR ID	DWR_RD0341_01_s_2019_32				
Comment Code					
V2 : Remove the wild growth other than native grasses from the levee slopes.					
Inspector Comment					
Remove arundo from waterside slope.

View looking downslope at arundo on the waterside (Spring 2019).

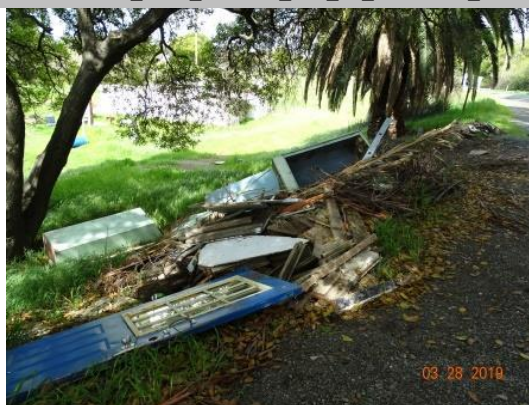
Photo 1 of 1 : SP_2019_RD0341_167_33_20190329_00056.jpg

LM Start	1.96	Rating **	M	Issue No.	33
LM End	1.96	Issue Type +	Ma	Location *	LS
Category	Earthen Levee			GPS Latitude/Longitude	
				Start	End
Item	Encroachments			38.113663 °	38.113663 °
				-121.684131 °	-121.684131 °
DWR ID	DWR_RD0341_01_s_2019_33				
Comment Code					
GA : Garbage					
Inspector Comment					
Remove garbage from landside slope.

View looking upstream at garbage pile on the landside slope (Spring 2019).

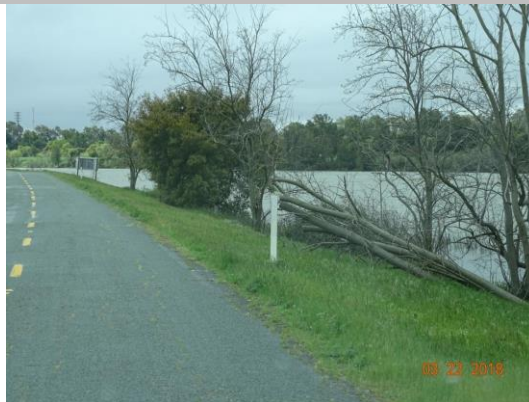
Photo 1 of 1 : SP_2019_RD0341_167_21_20190311_00002.jpg

LM Start	2.19	Rating **	M	Issue No.	21
LM End	2.19	Issue Type +	Ma	Location *	WS
Category	Earthen Levee			GPS Latitude/Longitude	
				Start	End
Item	Encroachments			38.113144 °	38.113144 °
				-121.687601 °	-121.687601 °
DWR ID	DWR_RD0341_01_s_2018_21				
Comment Code					
TR : Tree or limb					
Inspector Comment					
Remove fallen tree on waterside slope.

View of fallen tree on waterside slope.

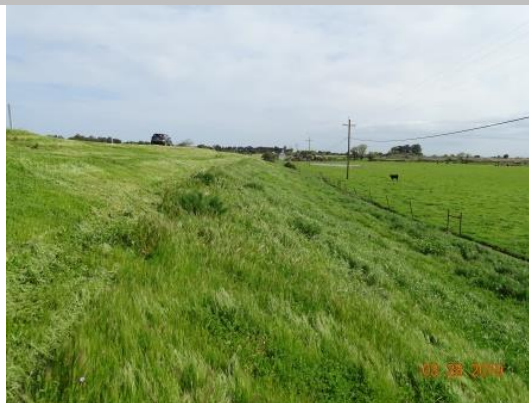
Photo 1 of 1 : SP_2019_RD0341_167_26_20190329_00052.jpg

LM Start	2.56	Rating **	M	Issue No.	26
LM End	2.80	Issue Type +	Ma	Location *	LS
Category	Earthen Levee			GPS Latitude/Longitude	
				Start	End
Item	Vegetation			38.108932 °	38.105813 °
				-121.691837 °	-121.693558 °
DWR ID	DWR_RD0341_01_s_2019_26				
Comment Code					
V1 : Control annual grass and weeds on the levee slopes and easements.					
Inspector Comment					
Maintain annual vegetation down to the landside toe.

View looking downstream at annual vegetation on the landside slope (Spring 2019).

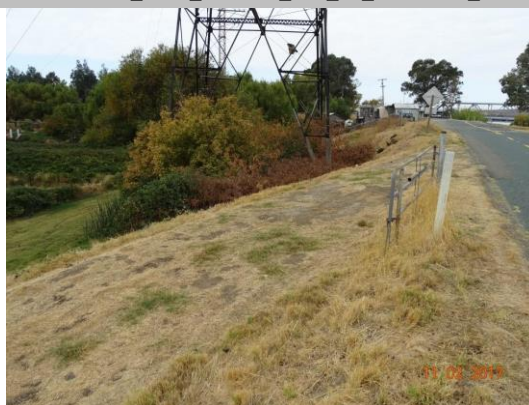
Photo 1 of 1 : SP_2019_RD0341_167_22_20190311_00003.jpg

LM Start	3.21	Rating **	M	Issue No.	22
LM End	3.21	Issue Type +	Ma	Location *	LS
Category	Earthen Levee			GPS Latitude/Longitude	
				Start	End
Item	Vegetation			38.104677 °	38.104677 °
				-121.700030 °	-121.700030 °
DWR ID	DWR_RD0341_01_f_2017_22				
Comment Code					
V2 : Remove the wild growth other than native grasses from the levee slopes.					
Inspector Comment					
Remove or thin wild vegetation at base of electrical transmission tower to allow visibility and access to slope and toe.

View of wild vegetation at base of electrical transmission tower.

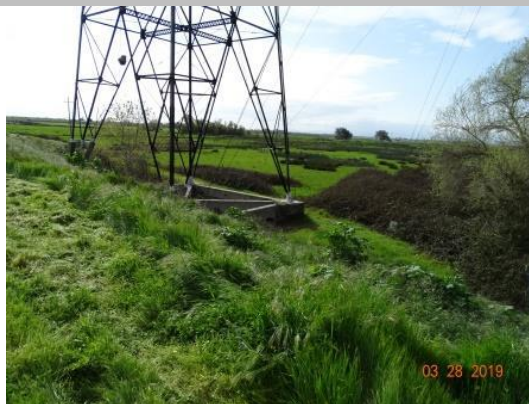
Photo 1 of 1 : SP_2019_RD0341_167_25_20190329_00050.jpg

LM Start	3.22	Rating **	U	Issue No.	25
LM End	3.22	Issue Type +	Ma	Location *	LS
Category	Earthen Levee			GPS Latitude/Longitude	
				Start	End
Item	Vegetation			38.104687 °	38.104687 °
				-121.700207 °	-121.700207 °
DWR ID	DWR_RD0341_01_s_2019_25				
Comment Code					
V1 : Control annual grass and weeds on the levee slopes and easements.					
Inspector Comment					
Maintain annual vegetation on the landside slope.

View looking downstream at annual vegetation on the landside slope (Spring 2019).

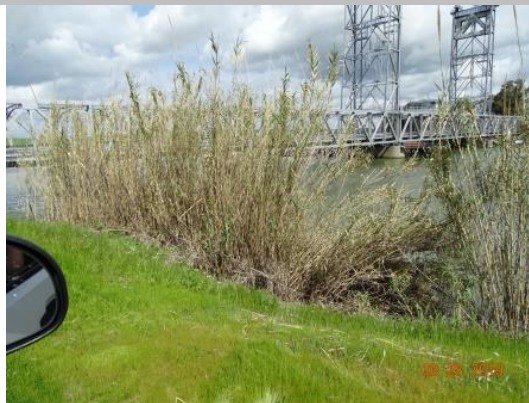
Photo 1 of 1 : SP_2019_RD0341_167_35_20190329_00058.jpg

LM Start	3.27	Rating **	M	Issue No.	35
LM End	3.27	Issue Type +	Ma	Location *	WS
Category	Earthen Levee			GPS Latitude/Longitude	
				Start	End
Item	Vegetation			38.105058 °	38.105058 °
				-121.701046 °	-121.701046 °
DWR ID	DWR_RD0341_01_s_2019_35				
Comment Code					
V2 : Remove the wild growth other than native grasses from the levee slopes.					
Inspector Comment					
Remove arundo from the waterside slope.

View looking upstream at arundo on the waterside slope (Spring 2019).

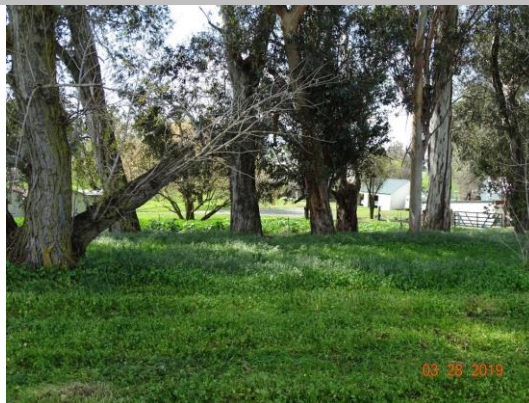
Photo 1 of 1 : SP_2019_RD0341_168_36_20190329_00086.jpg

LM Start	3.36	Rating **	M	Issue No.	36
LM End	3.36	Issue Type +	Ma	Location *	LS
Category	Earthen Levee			GPS Latitude/Longitude	
				Start	End
Item	Vegetation			38.105301 °	38.105301 °
				-121.702634 °	-121.702634 °
DWR ID	DWR_RD0341_02_s_2019_36				
Comment Code					
V1 : Control annual grass and weeds on the levee slopes and easements.					
Inspector Comment					
Maintain annual vegetation on the landside slope

View looking downslope at annual vegetation on the landside slope (Spring 2019).

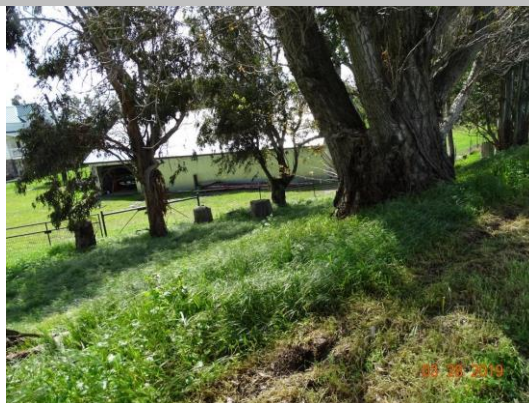
Photo 1 of 1 : SP_2019_RD0341_168_38_20190329_00087.jpg

LM Start	3.43	Rating **	M	Issue No.	38
LM End	3.93	Issue Type +	Ma	Location *	LS
Category	Earthen Levee			GPS Latitude/Longitude	
				Start	End
Item	Vegetation			38.104964 °	38.098390 °
				-121.703796 °	-121.706334 °
DWR ID	DWR_RD0341_02_s_2019_38				
Comment Code					
V1 : Control annual grass and weeds on the levee slopes and easements.					
Inspector Comment					
Maintain annual vegetation on the landside slope

View looking downslope at annual vegetation on the landside slope (Spring 2019).

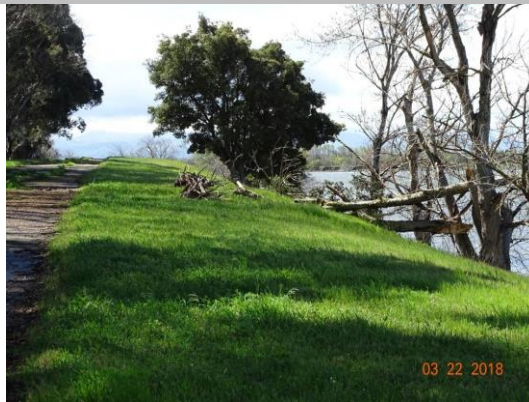
Photo 1 of 1 : SP_2019_RD0341_168_44_20190311_00012.jpg

LM Start	3.48	Rating **	M	Issue No.	44
LM End	3.48	Issue Type +	Ma	Location *	WS
Category	Earthen Levee			GPS Latitude/Longitude	
				Start	End
Item	Encroachments			38.104454 °	38.104454 °
				-121.704275 °	-121.704275 °
DWR ID	DWR_RD0341_02_s_2018_44				
Comment Code					
TR : Tree or limb					
Inspector Comment					
Remove tree limbs from waterside shoulder.

Tree limbs on waterside shoulder should be removed.

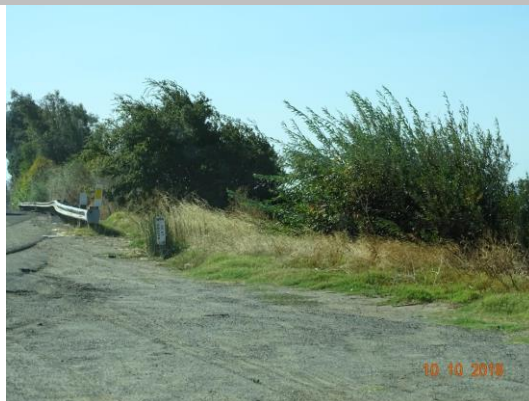
Photo 1 of 2 : SP_2019_RD0341_168_41_20190311_00005.jpg

LM Start	3.94	Rating **	U	Issue No.	41
LM End	6.14	Issue Type +	Ma	Location *	WS
Category	Earthen Levee			GPS Latitude/Longitude	
				Start	End
Item	Vegetation			38.098158 °	38.080223 °
				-121.706320 °	-121.730312 °
DWR ID	DWR_RD0341_02_s_2017_41				
Comment Code					
V2 : Remove the wild growth other than native grasses from the levee slopes.					
Inspector Comment					
Remove the unwanted vegetation from the waterside shoulder and slope.

Vegetation looking downstream at the beginning of where the levee is on Highway 160 (October 2018).

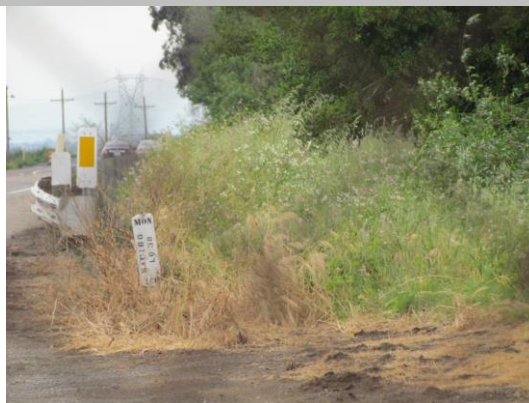
Photo 2 of 2 : SP_2019_RD0341_168_41_20190311_00006.jpg

Looking downstream from levee mile 3.94 at tall unwanted weeds and other vegetation on the waterside shoulder and slope.

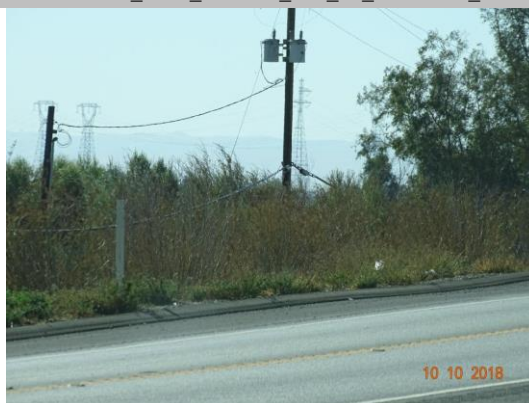
Photo 1 of 2 : SP_2019_RD0341_168_43_20190311_00010.jpg

LM Start	3.97	Rating **	M	Issue No.	43
LM End	6.03	Issue Type +	Ma	Location *	LS
Category	Earthen Levee			GPS Latitude/Longitude	
				Start	End
Item	Vegetation			38.097782 °	38.080143 °
				-121.706262 °	-121.728330 °
DWR ID	DWR_RD0341_02_f_2017_43				
Comment Code					
V2 : Remove the wild growth other than native grasses from the levee slopes.					
Inspector Comment					
Remove the unwanted vegetation from the landside shoulder, slope and toe.

View of vegetation on the land side slope where the levee is on Highway 160 (October 2018).

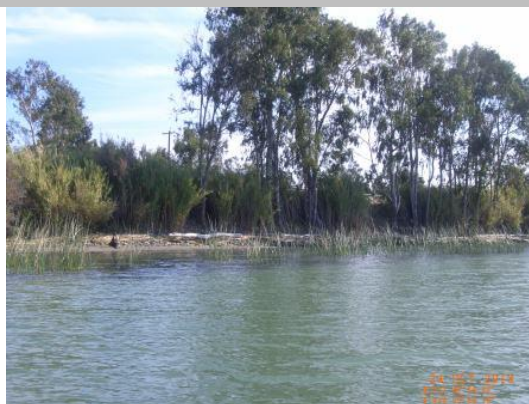
Photo 1 of 1 : SP_2019_RD0341_168_37_20190311_00004.jpg

LM Start	4.00	Rating **	M	Issue No.	37
LM End	4.19	Issue Type +	Ma	Location *	WS
Category	Supplemental			GPS Latitude/Longitude	
				Start	End
Item	2017 USACE Erosion Survey, DRAFT			38.097398 °	38.094590 °
				-121.706321 °	-121.706393 °
DWR ID	DWR_RD0341_02_f_2018_37				
Comment Code					
Inspector Comment					
2017 Site ID: SAC 8.2 L					
Status: Eroding					
2017 Field Notes: Minor new erosion.					
Site History: 2011 - Large new erosion pocket probably hidden by vegetation in the past.

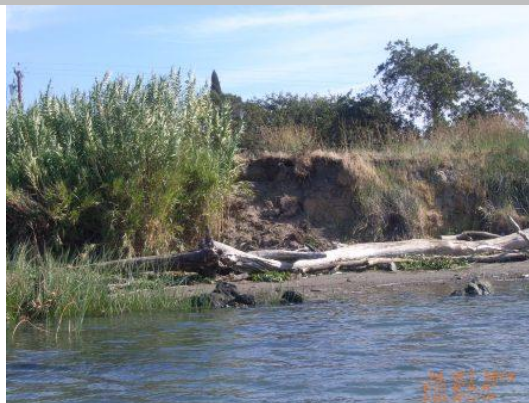
Photo 1 of 1 : SP_2019_RD0341_168_35_20190311_00003.jpg

LM Start	4.47	Rating **	U	Issue No.	35
LM End	4.70	Issue Type +	Ma	Location *	WS
Category	Supplemental			GPS Latitude/Longitude	
				Start	End
Item	2017 USACE Erosion Survey, DRAFT			38.090620 °	38.087425 °
				-121.706684 °	-121.707639 °
DWR ID	DWR_RD0341_02_f_2018_35				
Comment Code					
Inspector Comment					
2017 Site ID: SAC 8.0 L Status: Critical 2017 Field Notes: Site extended downstream Site History: 1999 - New small slump in eroded bank. 2005 - Reach extended because of vertical bank along the roadway upstream. 2011 - More slumping since last year. 2012 - Site upgraded to critical. Very steep slope which may be effecting the highway on top of the levee. 2015 - New erosion towards the downstream end of site.

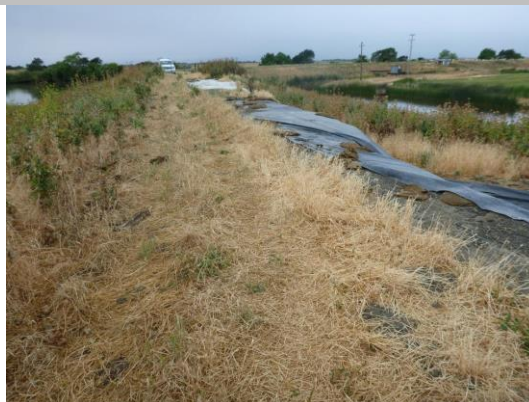
Photo 1 of 3 : SP_2019_RD0341_168_42_20190311_00007.jpg

LM Start	4.75	Rating **	A/W	Issue No.	42
LM End	4.79	Issue Type +	Ma	Location *	
Category	Supplemental			GPS Latitude/Longitude	
				Start	End
Item	2017 Storm Damage			38.086641 °	38.086119 °
				-121.707545 °	-121.707912 °
DWR ID	DWR_RD0341_02_f_2017_42				
Comment Code					
Inspector Comment					
Levee Evaluation Comments					
Description:					
Site ID No:65					
Site Designation:DWR_RD0341_02_s_2012_8					
Repair Type: Erosion					
Rating:Area of Concern					
Field Date:6/8/2017					
Notes: hwy 160 forms levee crown road, erosion has encroached into paved crown, crown 38' wide. This site is currently under contract for repair under FSRP.

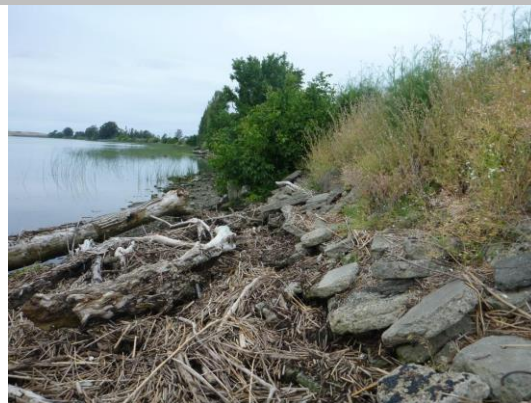
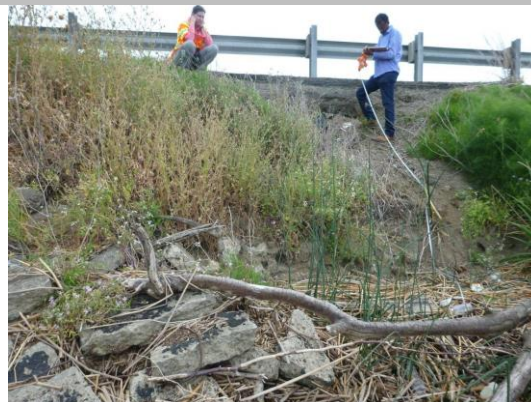
LM Start	4.75	Rating **	A/W	Issue No.	42 (cont)
LM End	4.79	Issue Type +	Ma	Location *	
Category	Supplemental			GPS Latitude/Longitude	
				Start	End
Item	2017 Storm Damage			38.086641 °	38.086119 °
				-121.707545 °	-121.707912 °
DWR ID	DWR_RD0341_02_f_2017_42				
Comment Code					
Inspector Comment					
Levee Evaluation Comments					
Description:					
Site ID No:65					
Site Designation:DWR_RD0341_02_s_2012_8					
Repair Type: Erosion					
Rating:Area of Concern					
Field Date:6/8/2017					
Notes: hwy 160 forms levee crown road, erosion has encroached into paved crown, crown 38' wide. This site is currently under contract for repair under FSRP.

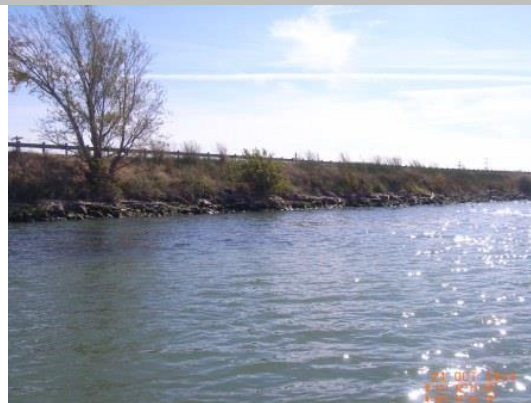
Photo 1 of 1 : SP_2019_RD0341_168_34_20190311_00002.jpg

LM Start	4.76	Rating **	A/W	Issue No.	34
LM End	5.01	Issue Type +	Ma	Location *	WS
Category	Supplemental			GPS Latitude/Longitude	
				Start	End
Item	2017 USACE Erosion Survey, DRAFT			38.086603 °	38.083954 °
				-121.707786 °	-121.710589 °
DWR ID	DWR_RD0341_02_f_2018_34				
Comment Code					
Inspector Comment					
2017 Site ID: SAC 7.9 L					
Status: Critical					
2017 Field Notes: Road base exposed in multiple locations. New tree popout observed.					
Site History: 2011 - Large slump section. 2012 - Site extended downstream, upgraded to critical, severe windwave. Slope is very steep and may be effecting the highway on top of the levee.

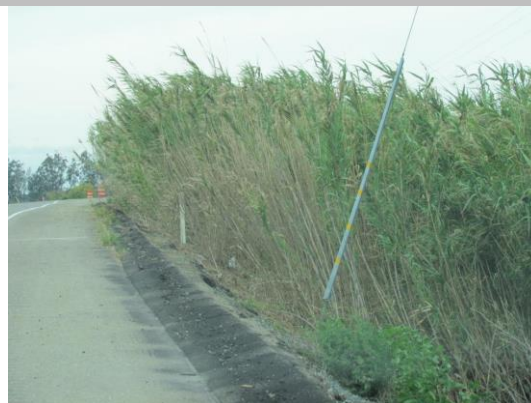
Photo 1 of 1 : SP_2019_RD0341_168_49_20190311_00015.jpg

LM Start	6.03	Rating **	U	Issue No.	49
LM End	6.10	Issue Type +	Ma	Location *	LS
Category	Earthen Levee			GPS Latitude/Longitude	
				Start	End
Item	Vegetation			38.080143 °	38.080125 °
				-121.728332 °	-121.729662 °
DWR ID	DWR_RD0341_02_f_2016_49				
Comment Code					
V2 : Remove the wild growth other than native grasses from the levee slopes.					
Inspector Comment					
Remove the arundo from the landside slope

RD 341 Landside slope from levee mile 6.03-6.10 tall unwanted growth of Arundo present on the levee section.

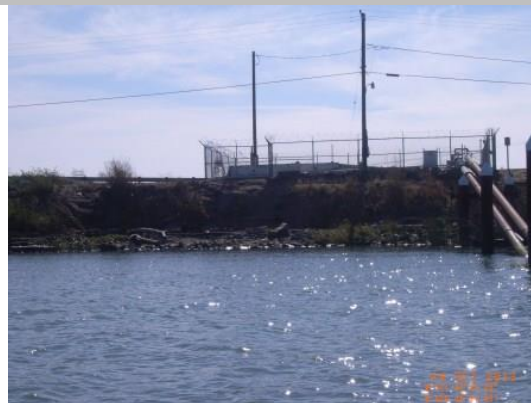
Photo 1 of 1 : SP_2019_RD0341_168_32_20190311_00001.jpg

LM Start	6.03	Rating **	U	Issue No.	32
LM End	6.16	Issue Type +	Ma	Location *	WS
Category	Supplemental			GPS Latitude/Longitude	
				Start	End
Item	2017 USACE Erosion Survey, DRAFT			38.080370 °	38.080526 °
				-121.728341 °	-121.730483 °
DWR ID	DWR_RD0341_02_f_2018_32				
Comment Code					
Inspector Comment					
2017 Site ID: SAC 7.3 L					
Status: Critical					
2017 Field Notes: No observed change..					
Site History: 2011 - Large slump at downstream end. Gully formed from surface runoff from the road. Shallow slumping throughout site.					
2012 - The gully at upstream end has increased in size and site continues to worsen.
